Victorian Forts Network RESOURCES

Topic:	Brickwork and Masonry
Date of issue:	14th July 2025
Author:	Lewis Sharp - with information and photos from Kevin Casey of the Diving Museum at Stokes Bay Battery no. 2
Content:	Step Tile at Battery no. 2

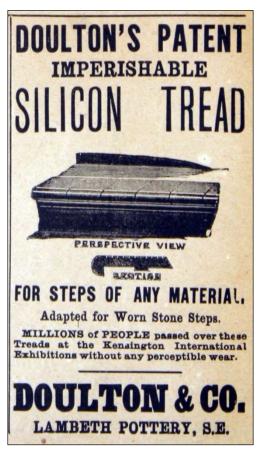
From Grace's Guide, dated 1898
